**MONITORING COMPLETED COASTAL PROJECTS PROGRAM**

MISCELLANEOUS PAPER CERC-91-10

**MONITORING OF COMPLETED BREAKWATERS  
AT CATTARAUGUS CREEK HARBOR, NEW YORK**

September 1991

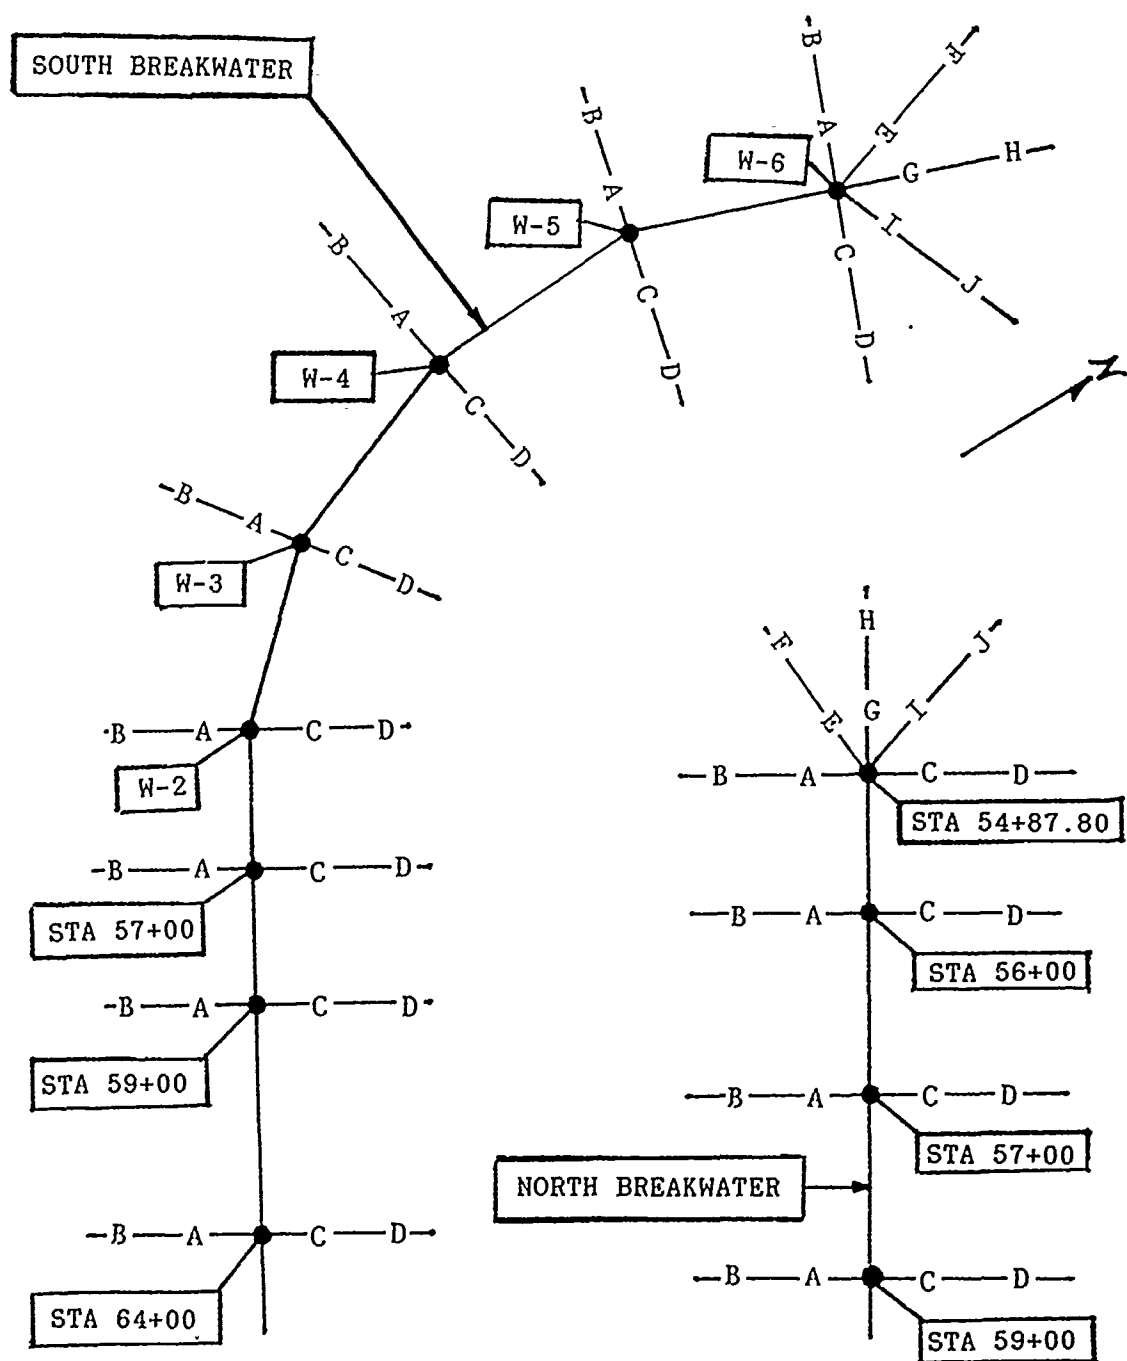
Figure 27. Sketch of target and surveyed stone locations

47. Stones along the lakeside of the south breakwater (points A and B on Figure 27) moved perpendicular to the breakwater center line -0.11 to 0.15 ft with an average movement inward of 0.01 ft. The stones rotated about the target -1.33 to 0.2 deg for an average clockwise movement (lakeward along breakwater axis) of 0.23 deg. Vertical stone movement was -0.1 to 0.2 ft with an average upheaval of 0.05 ft. The harborside stones (C and D, Figure 27) on the south breakwater moved perpendicular to the breakwater center line -0.12 to 0.24 ft for an average outward movement of 0.03 ft, rotated about the target -0.18 to 0.17 deg with an average clockwise movement of 0.03 deg, and moved vertically 0 to 0.2 ft with an average upheaval of 0.13 ft. At the breakwater head (W-6), stone radial movement from the target was -0.11 to 0.86 ft, rotation experienced about the target was -1.72 to 1.63 deg, and vertical movement was -0.6 to 0 ft. Measurements were not obtained for stone W-6B, which was covered; stone W-6D, which was not found in June 1985; and stone W-6F, which was on its side by summer 1984.

49. Stones along the lakeside of the north breakwater (C and D on Figure 27) moved perpendicular to the breakwater center line -0.01 to 0.06 ft for the period May-June 1983 to June 1985. The accompanying rotation about the target on the breakwater center line and change in elevation was -0.08 to 0.12 deg and -0.5 to 0.1 ft, respectively. The harborside stones along the trunk experienced values for ( $\Delta r$ ,  $\Delta \theta$ ,  $\Delta z$ ) of -0.01 to 0.06 ft, -0.08 to 0.12 deg, and -0.1 to 0.1 ft, and the head experienced values of -0.11 to 0.06 ft, -0.08 to 0.07 deg, and -0.1 to 0.0 ft, respectively. Not included in these values for the head section is an immediate movement of stone 54+87.80 F (shown in Figure 27) inward 4.07 ft with no change in rotation or elevation and its subsequent return the following survey. It is surmised that an initial surveying positioning error explains this anomaly. These values in addition to the structure cross sections indicate negligible damage to the north breakwater, which has been confirmed during subsequent field inspections. Figures 35 and 36 present cross sections taken at the north breakwater head. The surveys indicate that some scouring near the toe has occurred but has not affected structural integrity.

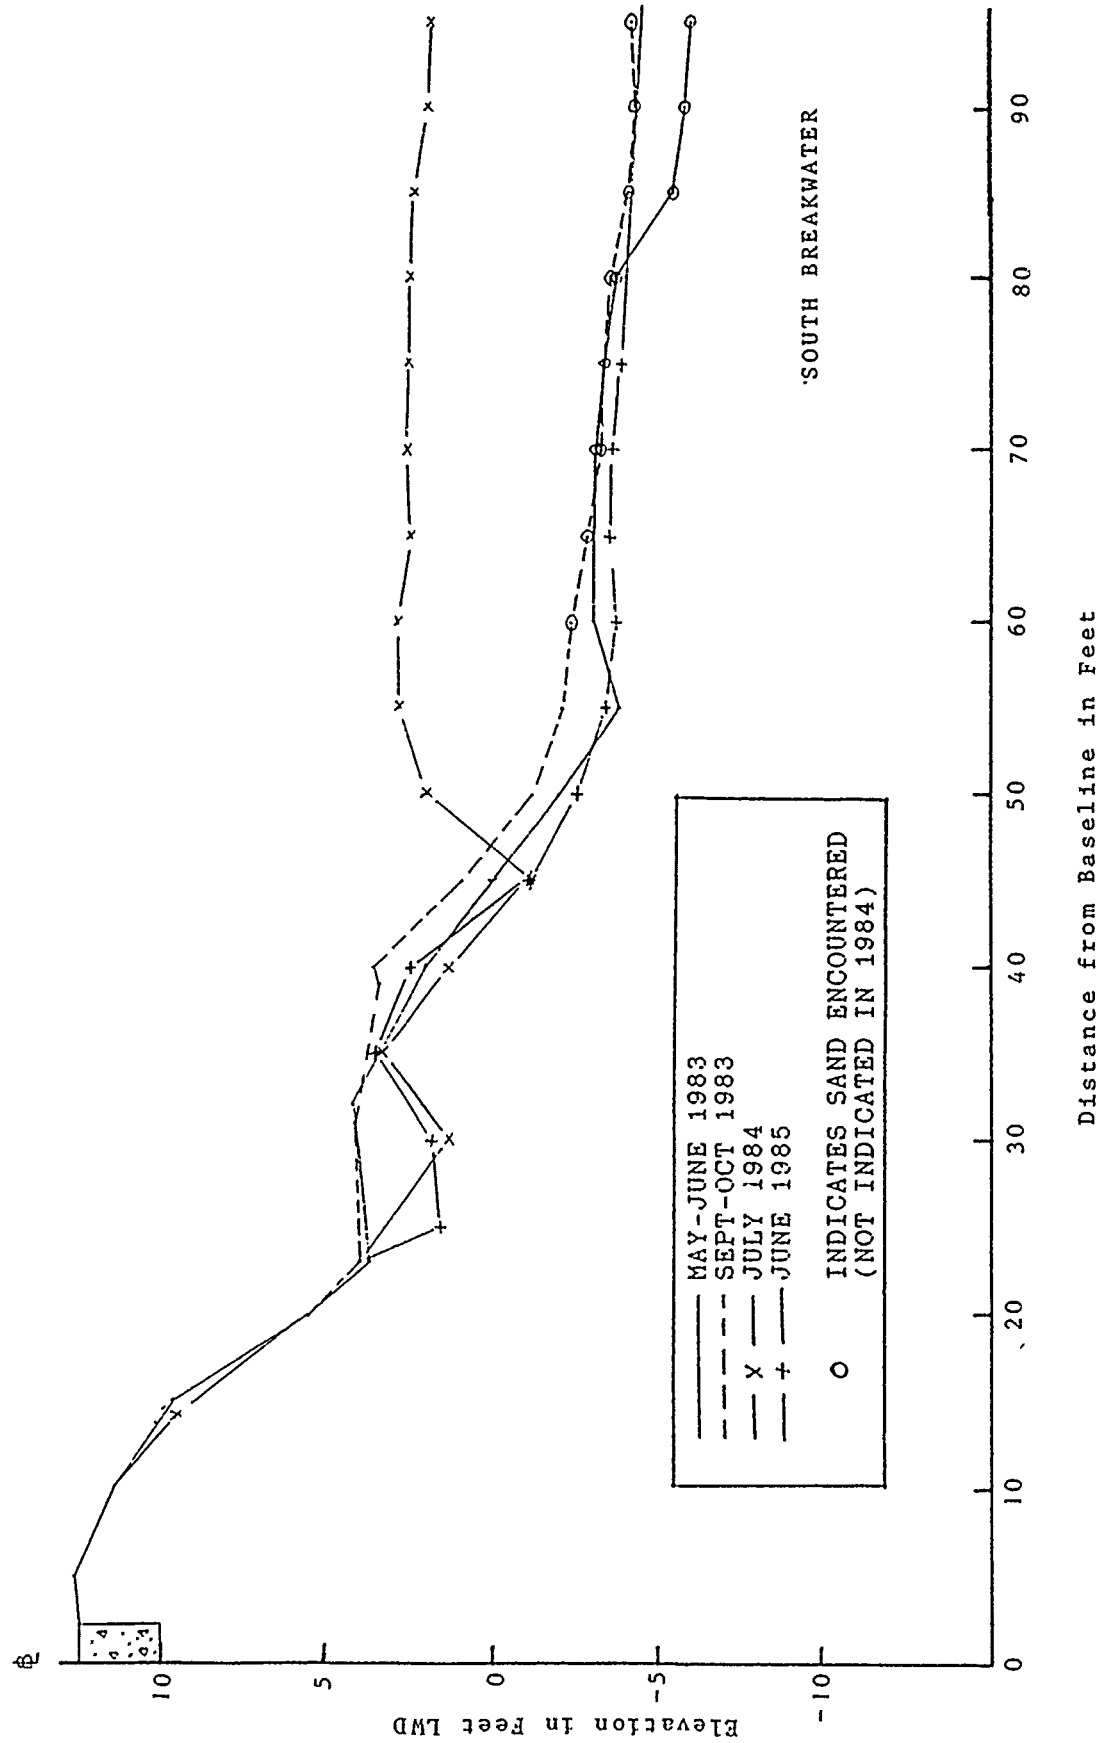
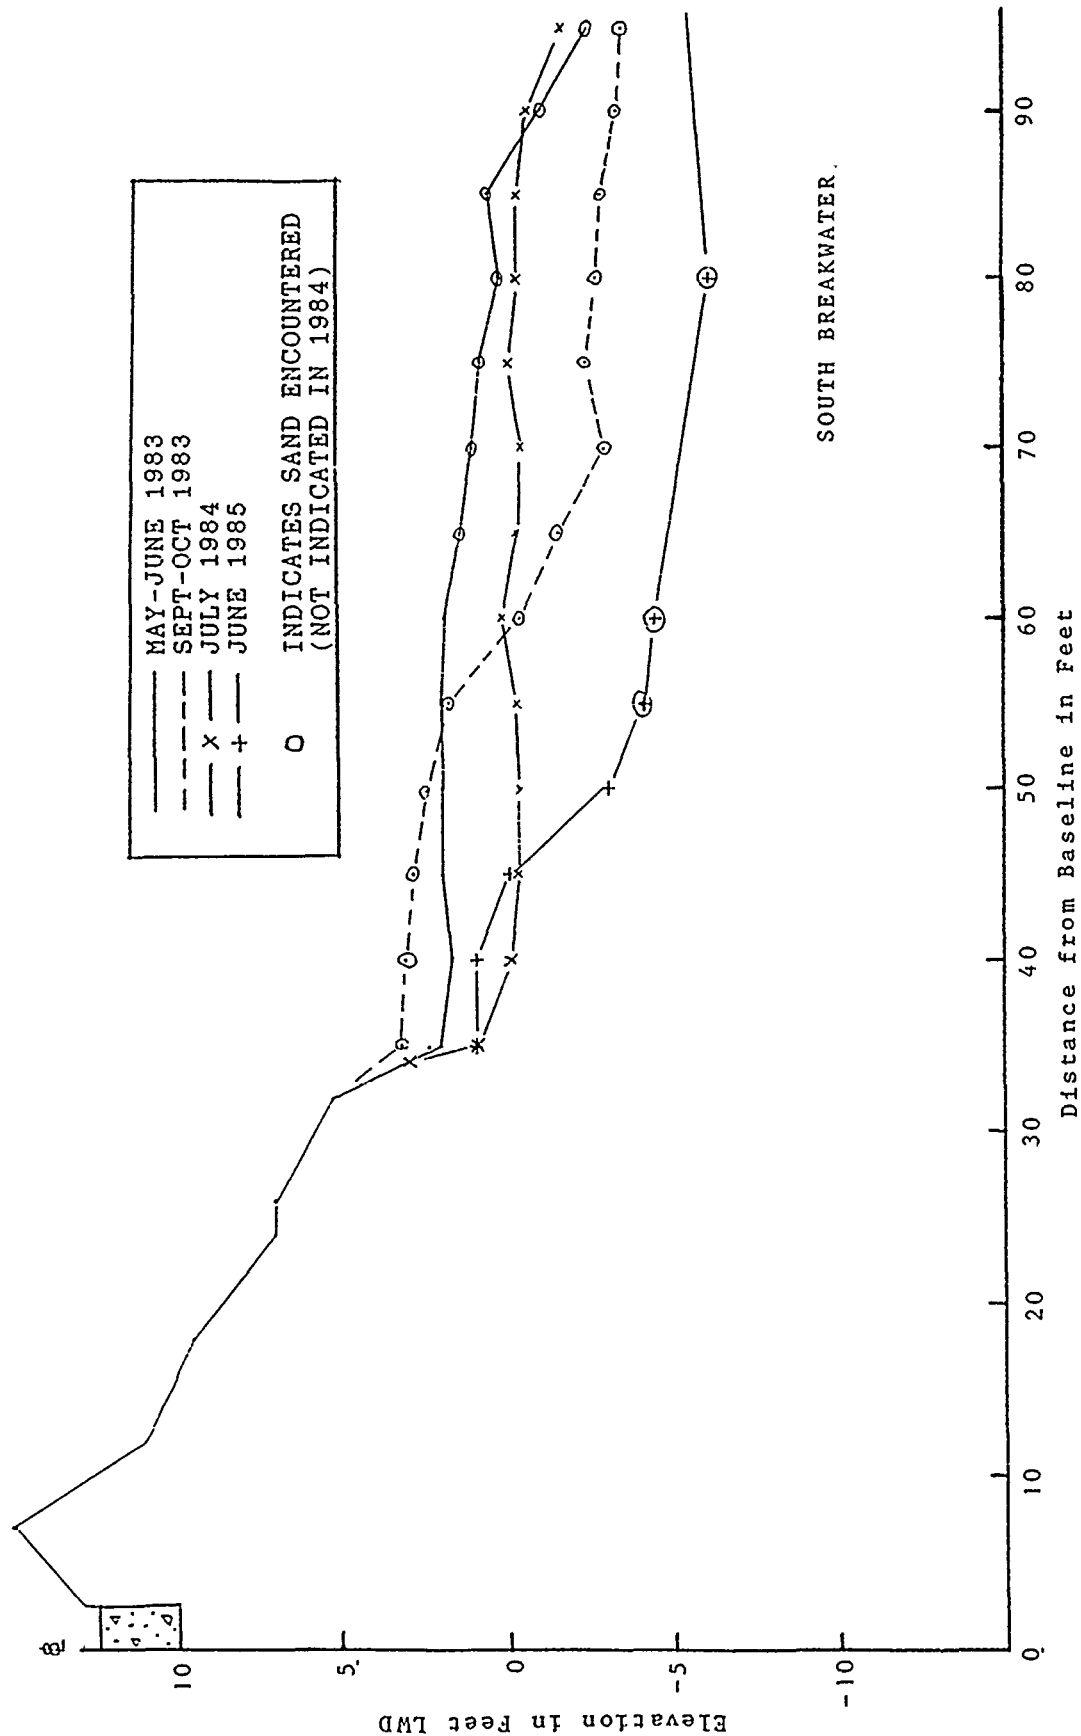
change in elevation of the target locations on the south and north breakwaters. Tables 6 and 7 present the measured stone movement. Figures 28 through 36 present structure cross sections for the south breakwater along the trunk (Sta 57+00) and the head (W-6) and the north breakwater head (Sta 54+87.8).

48. These values indicate negligible movement along the structure trunk. Stone W-2C moved outward 0.92 ft between September-October 1983 and July-August 1984 but moved inward 0.92 ft between July-August 1984 and June 1985, with negligible rotation or change in elevation. Stone W-2D also moved outward 3.46 ft from May-June 1983 to September-October 1983 and moved inward 3.44 ft the subsequent survey period, with negligible rotation or change in elevation. This suggests a surveying error. Structure cross sections taken along the trunk also indicate negligible movement. Figures 28 and 29 present cross sections of the structure trunk at Sta 57+00. Stone survey data of the head indicate minor damage has occurred. Cross sections of the head section

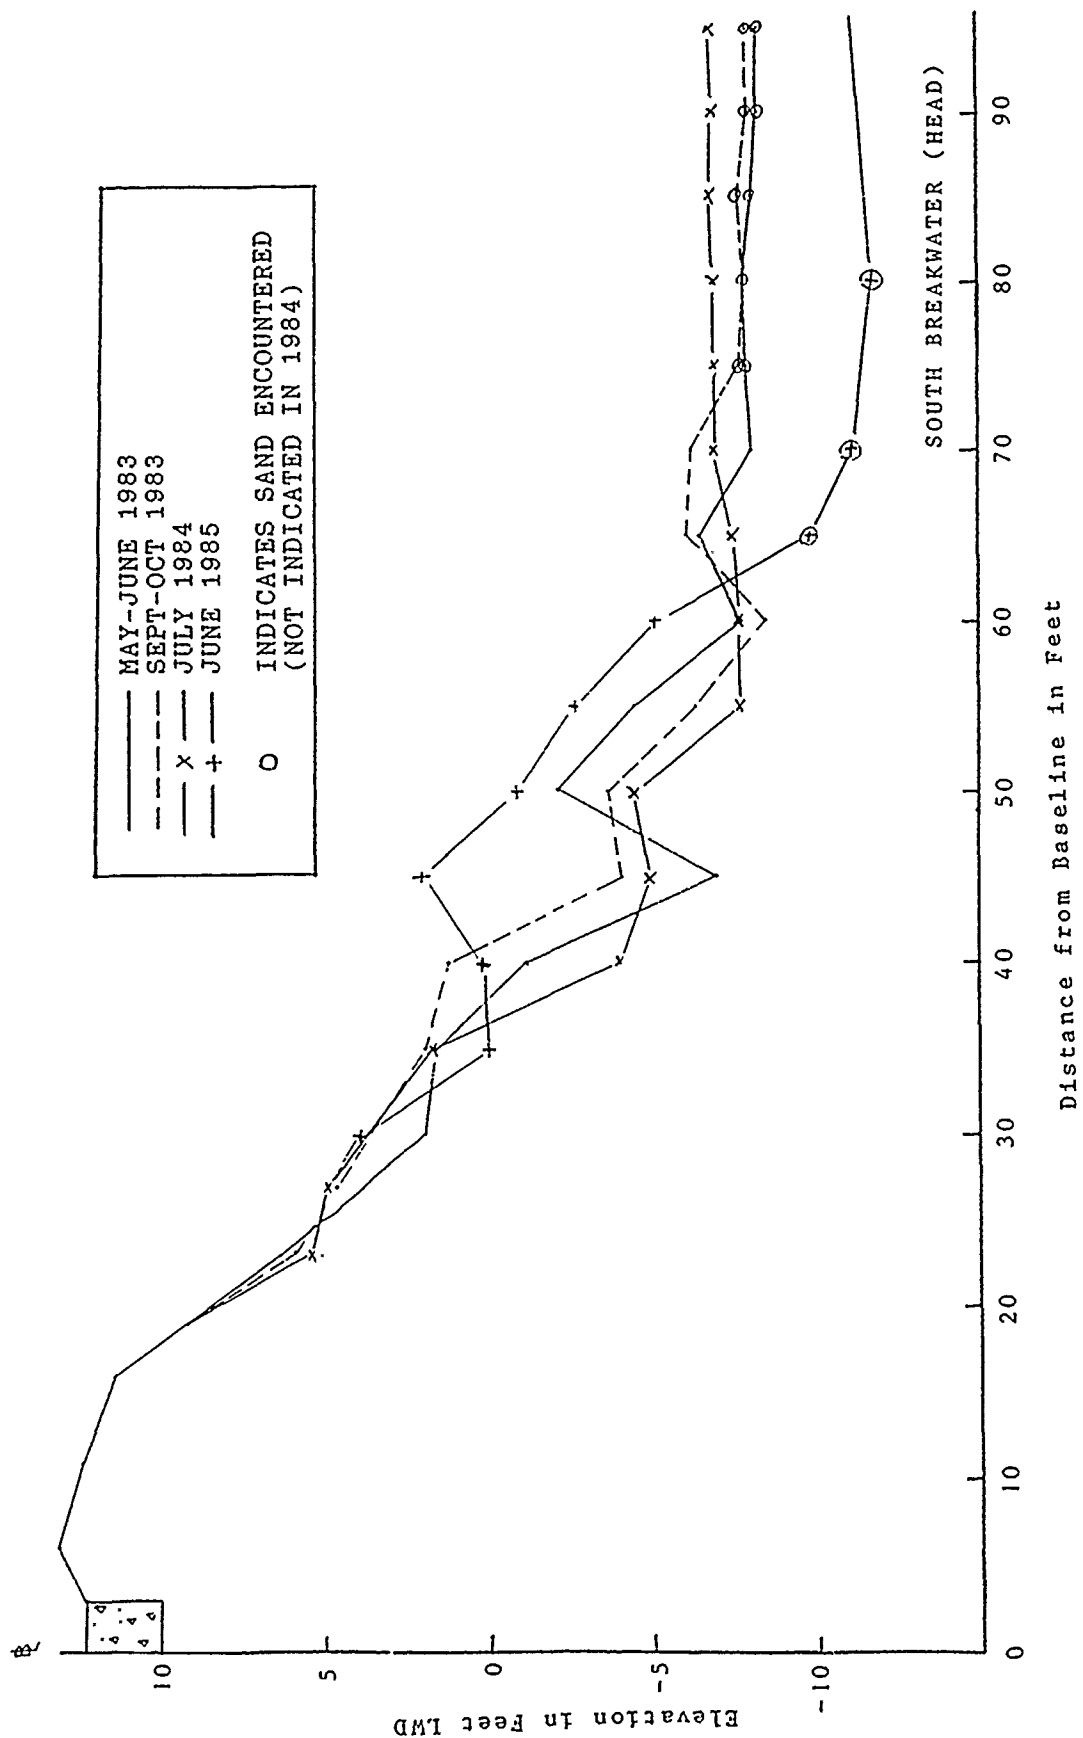
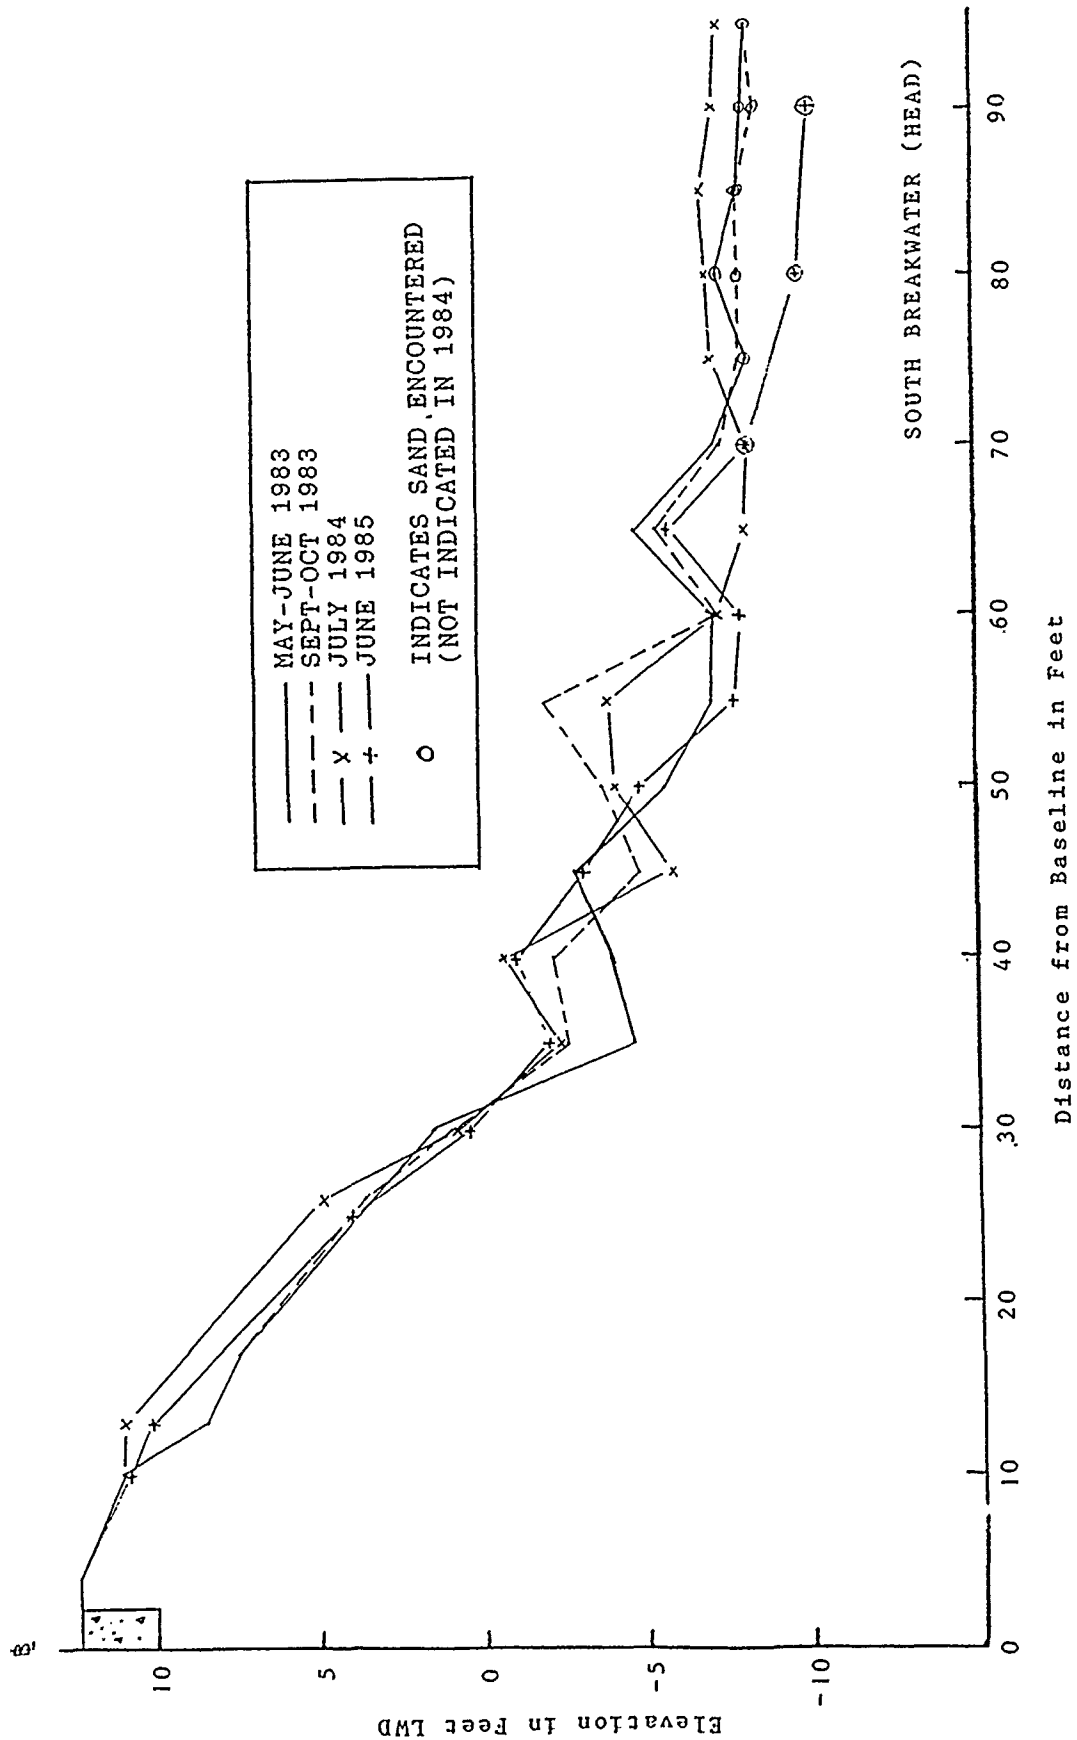
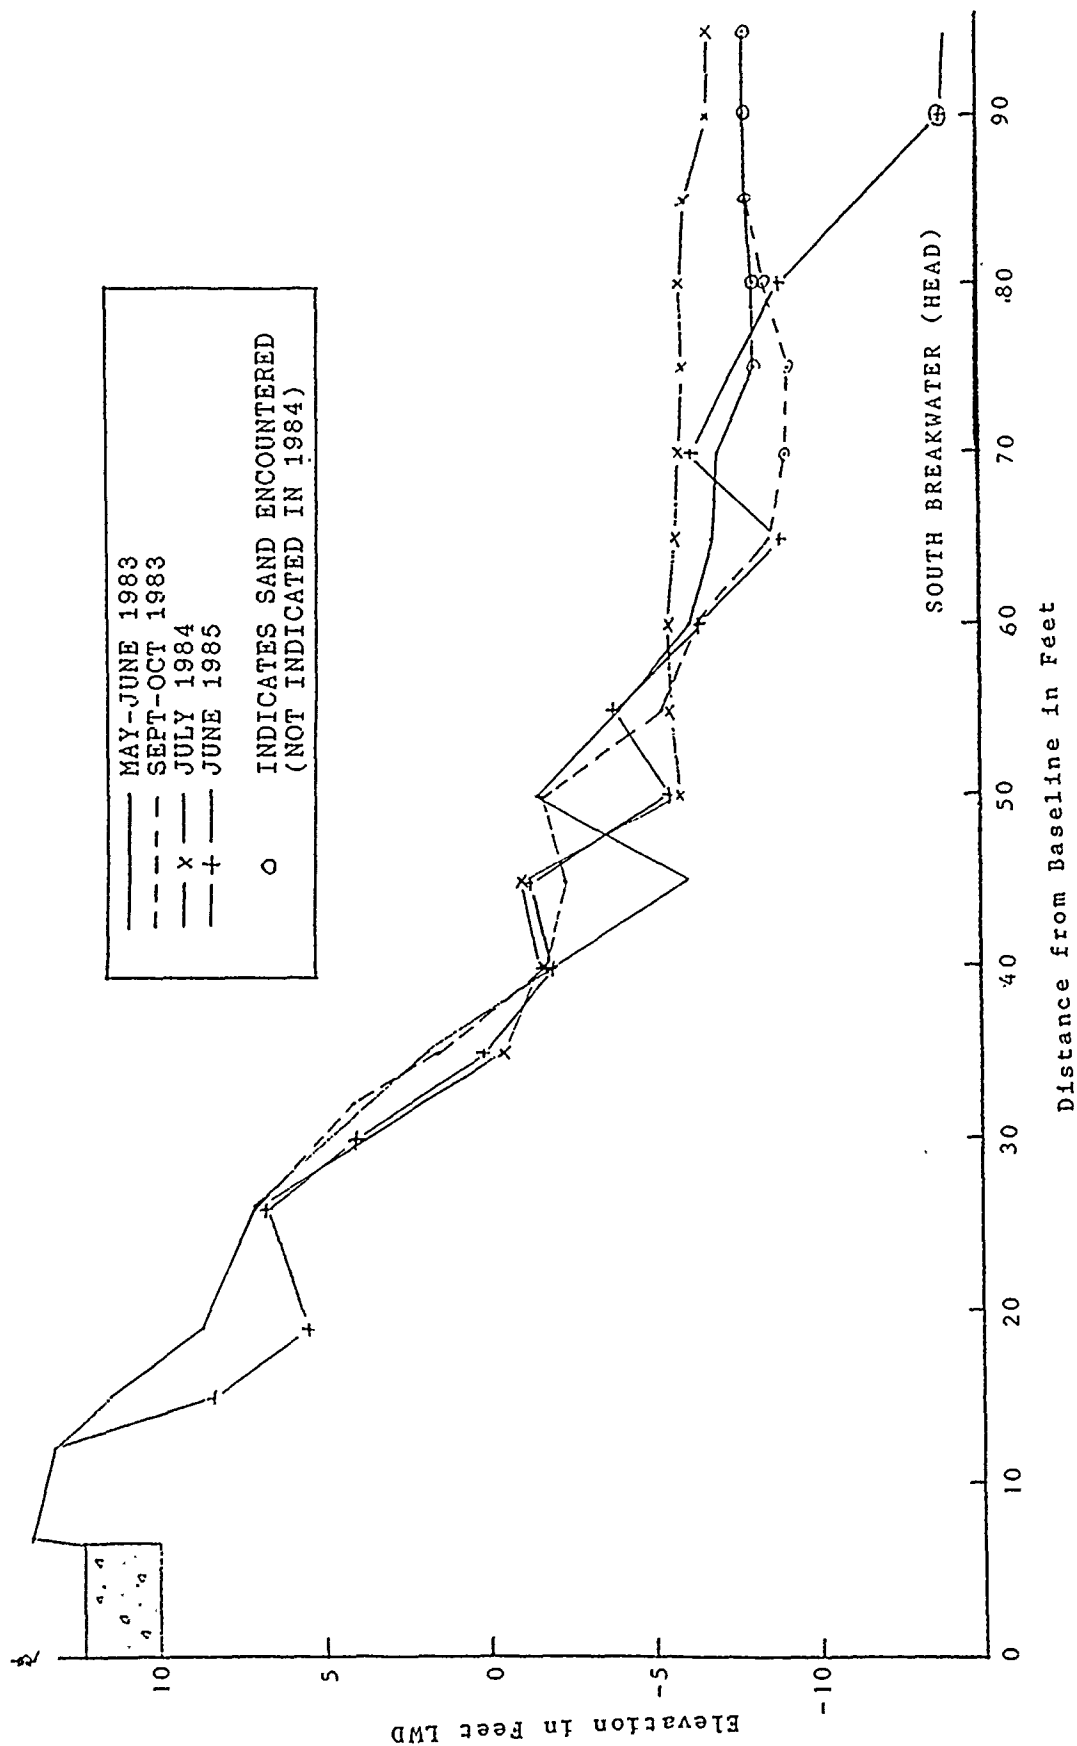
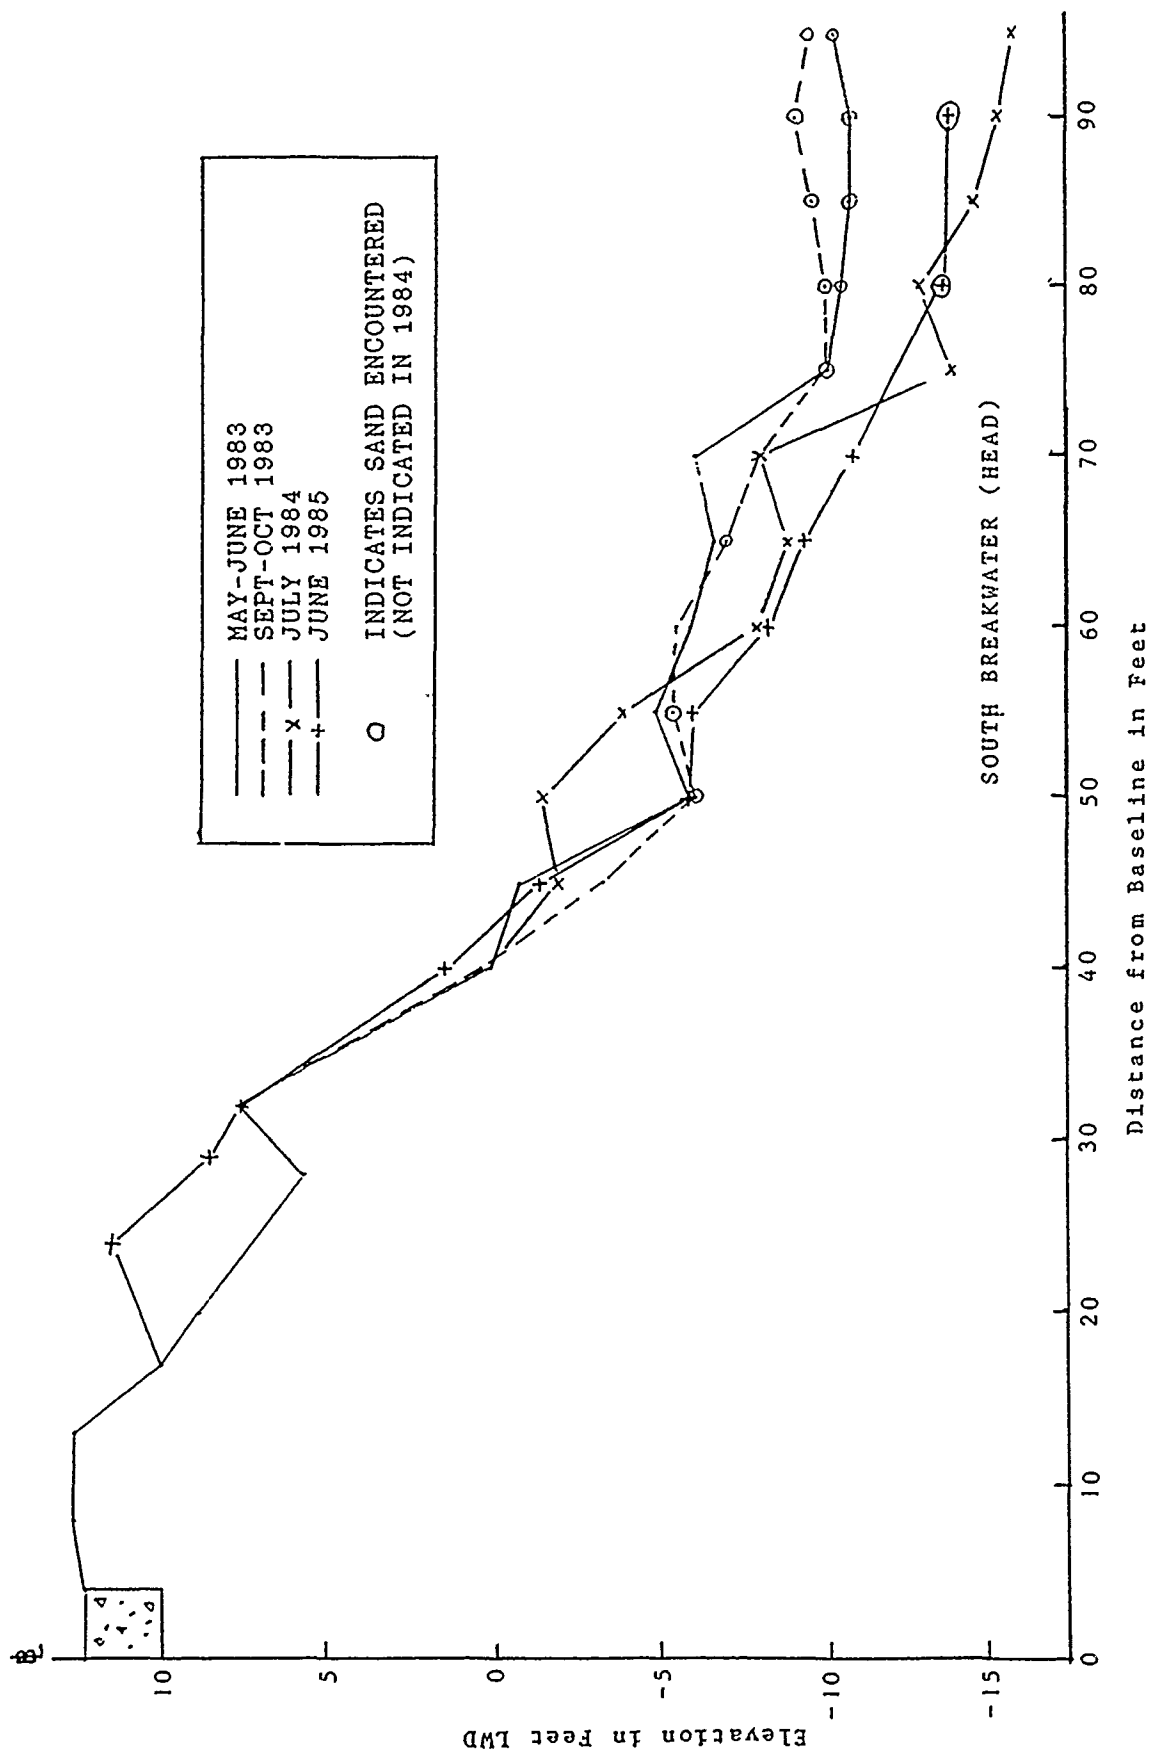
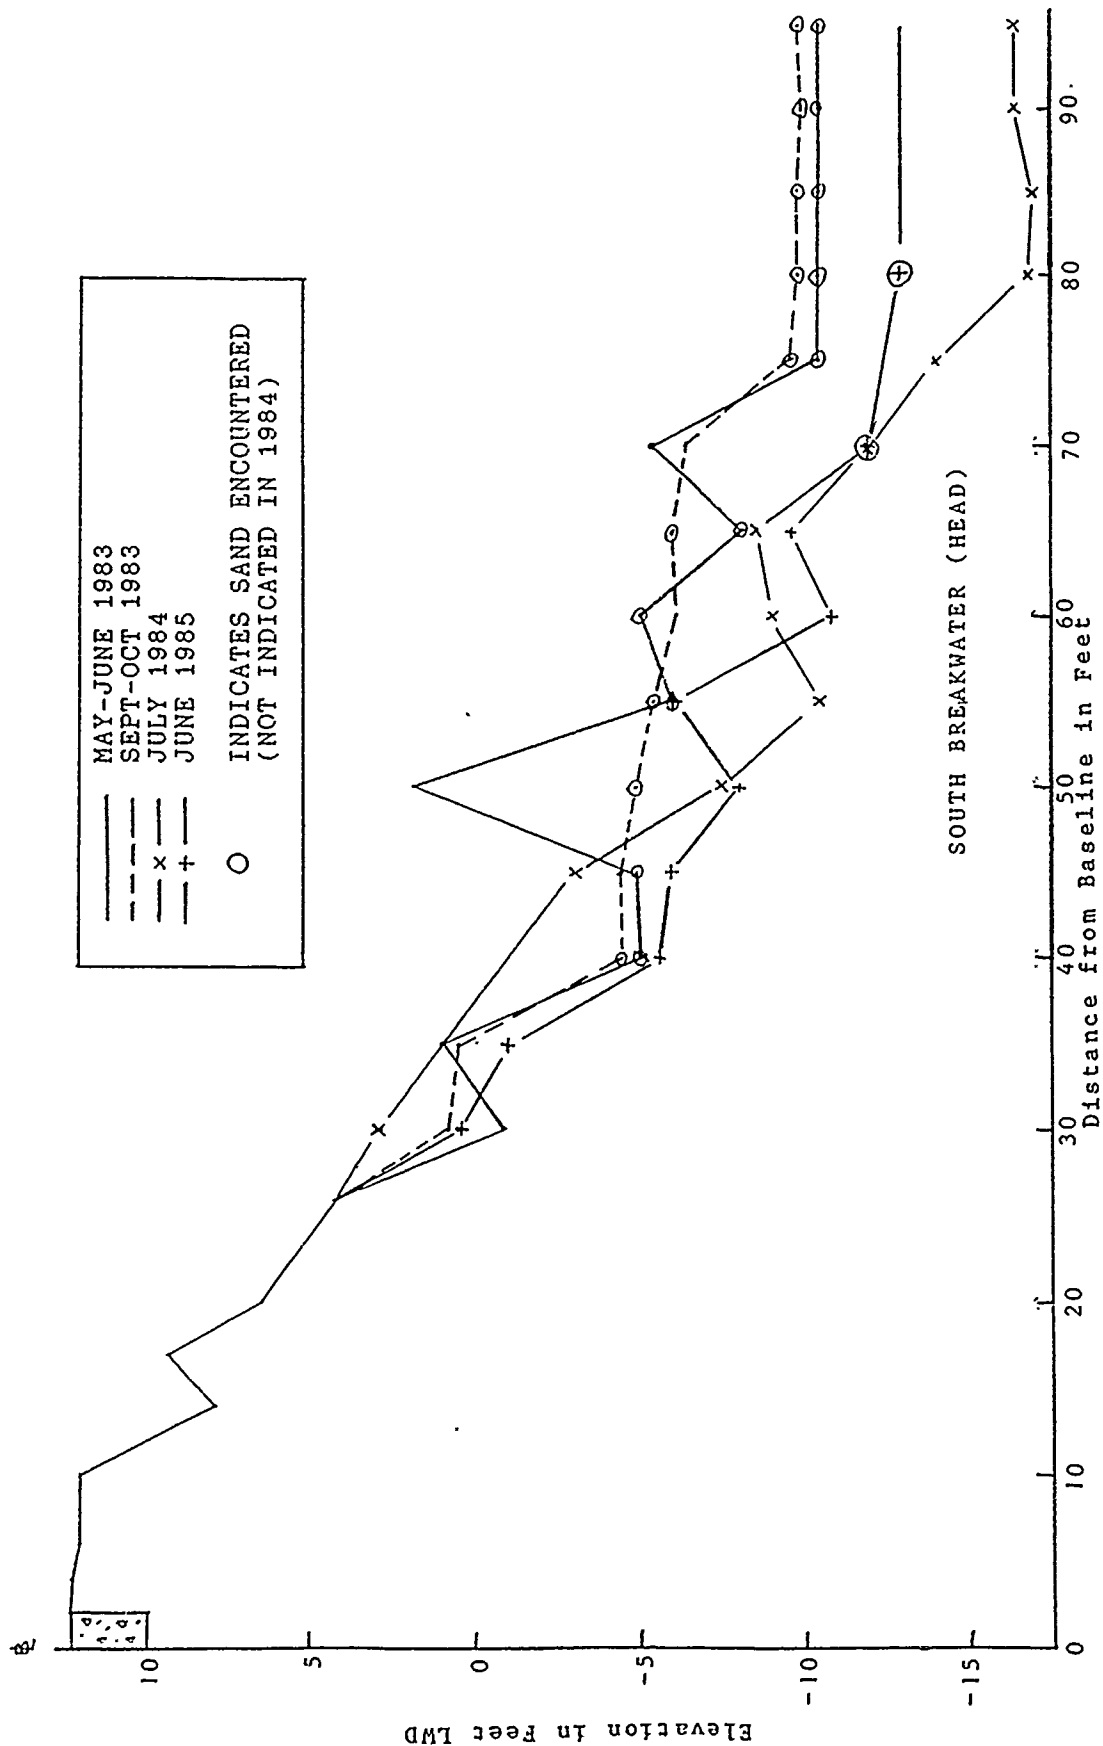
(W-6) are presented on Figures 30 through 34 and indicate minor stone steepening and scour near the toe.

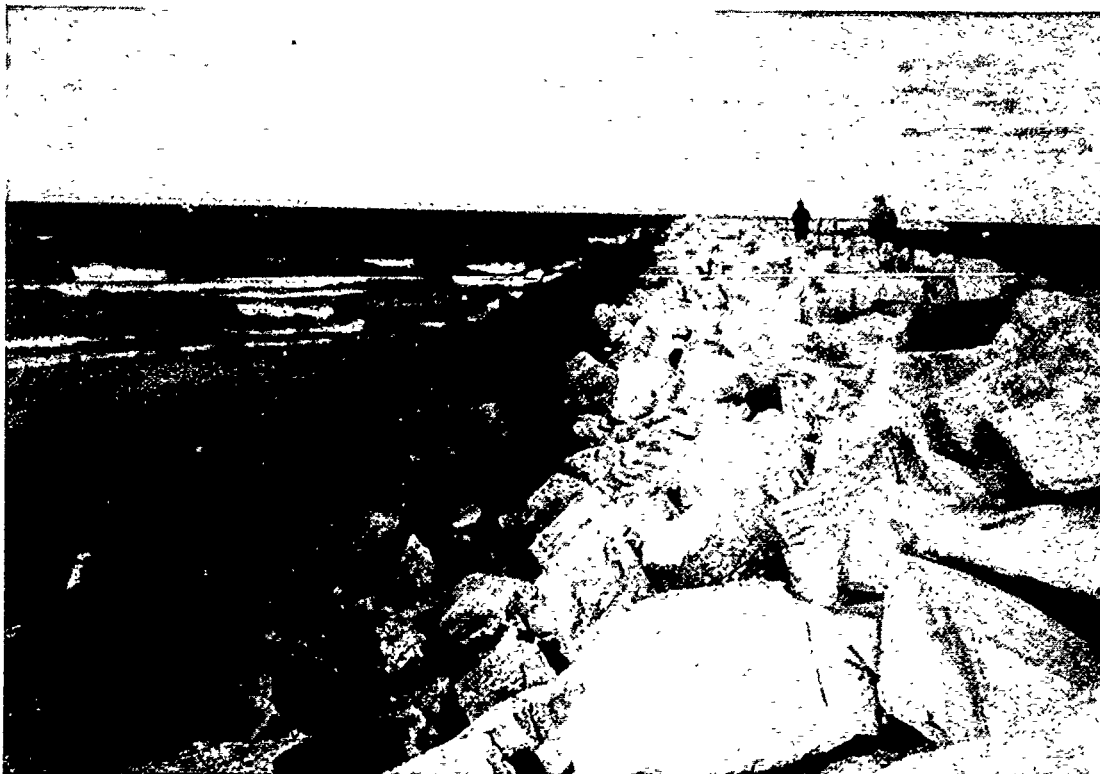
Figure 37. South breakwater, lakeside, 17 November 1988

51. To alleviate the potential detrimental effects of scour at the toe of the breakwaters, a sacrificial toe berm was constructed by placing one layer of armor over the bedding material as shown on the structure cross sections presented in Figures 16 and 17. Figures 37 and 38, taken in November 1988 of the south breakwater, show the toe berm protruding slightly above the

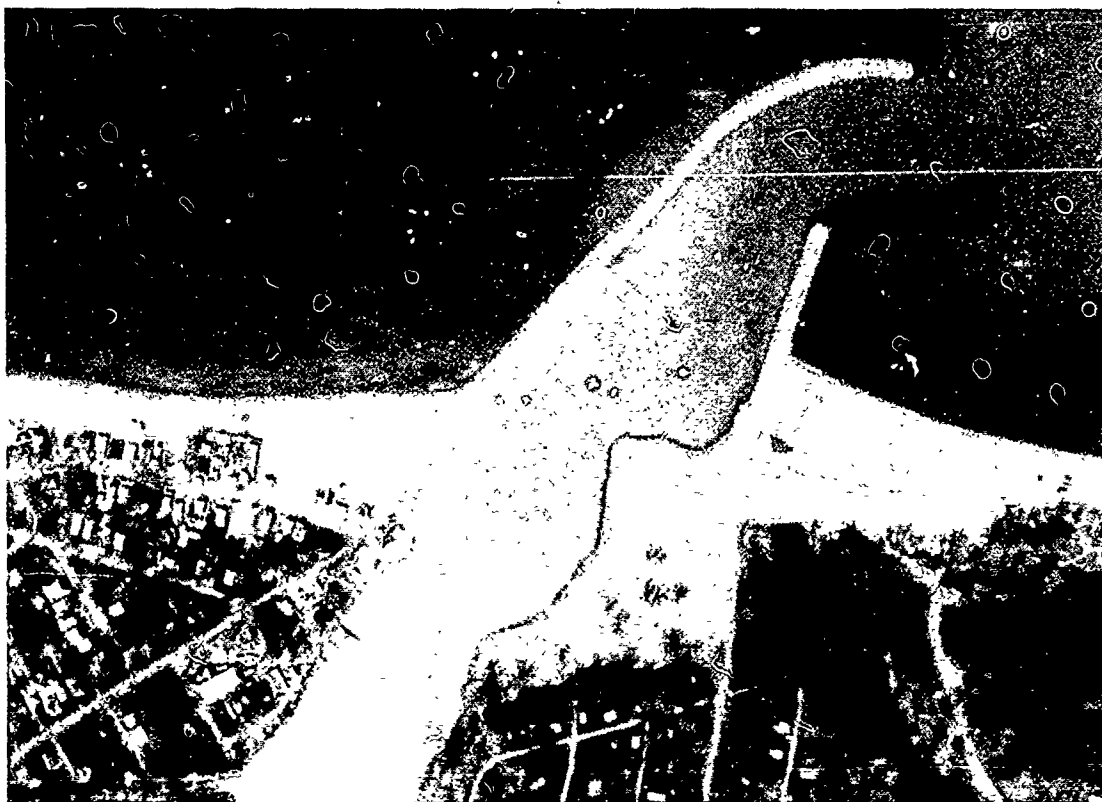
Figure 49. Cattaraugus Creek Harbor,  
13 May 1983, +3.6 LWD

54. To evaluate beach response to the presence of the harbor structures, profile surveys of the project area and the adjacent shoreline were taken November 1982, October 1983, August 1984, and July 1985. Survey lines were located at 100-ft intervals from 600 ft south of the south breakwater to 600 ft north of the north breakwater and at 500-ft intervals 3,500 ft farther south and 4,500 ft farther north, resulting in coverage of 10,000 ft of shoreline. The surveys were conducted by a combination of rod and level, lead line, and Fathometer from the back beach to 0.5 mile offshore. Figures 40-48 present comparative profiles for Sta 450+00, 465+00, 485+00, 490+00, 495+00, 501+00, 505+00, 525+00, and 550+00, respectively. Figures 49 and 50 present aerial views of the area near the breakwaters on 13 May 1983 and 26 October 1985.

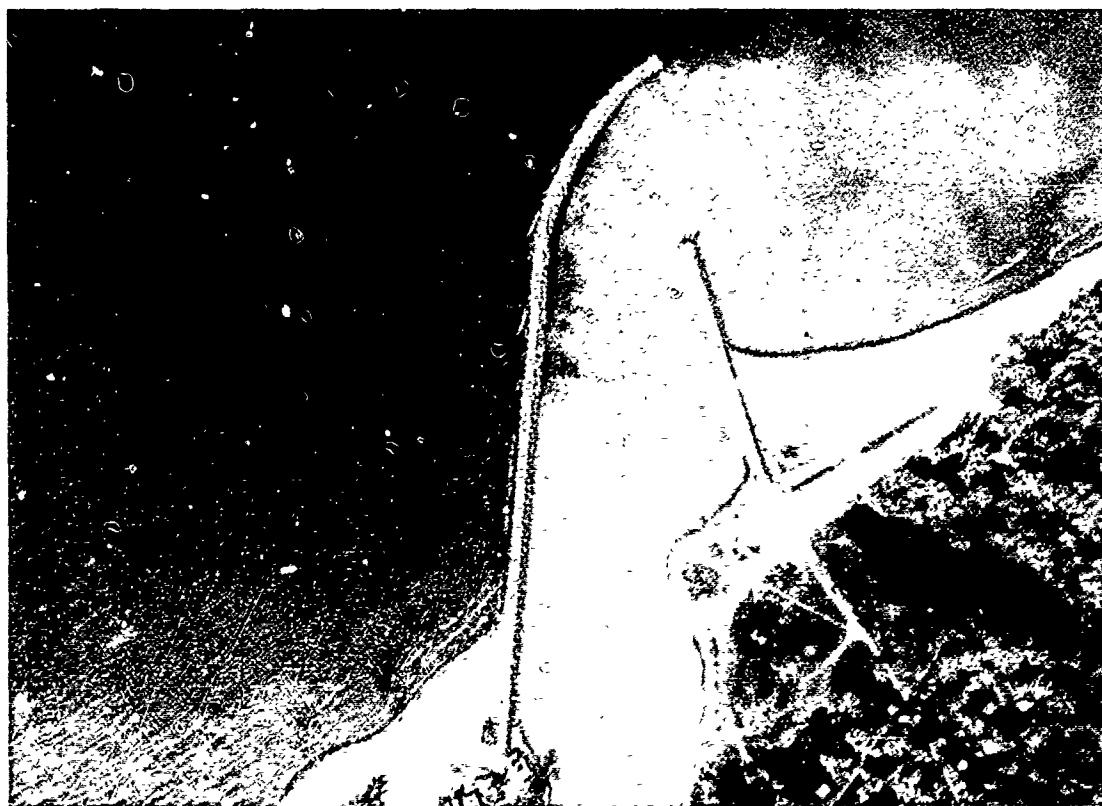
Figure 50. Cattaraugus Creek Harbor,  
26 October 1985, +3.5 LWD

92. The use of filter fabric was successful, at least to date. There were obvious indications of transport through the south breakwater lakeward of where the fabric had been installed (Figures 50 and 51). Figure 50 shows conditions with waves entering the mouth of the creek and pushing more sediment-laden water through the structure. Figure 51 shows the opposite conditions, with the clearer lake water penetrating into the channel. These are indications that sediment has been prevented from penetrating the structure and reaching the channel where filter fabric has been used.

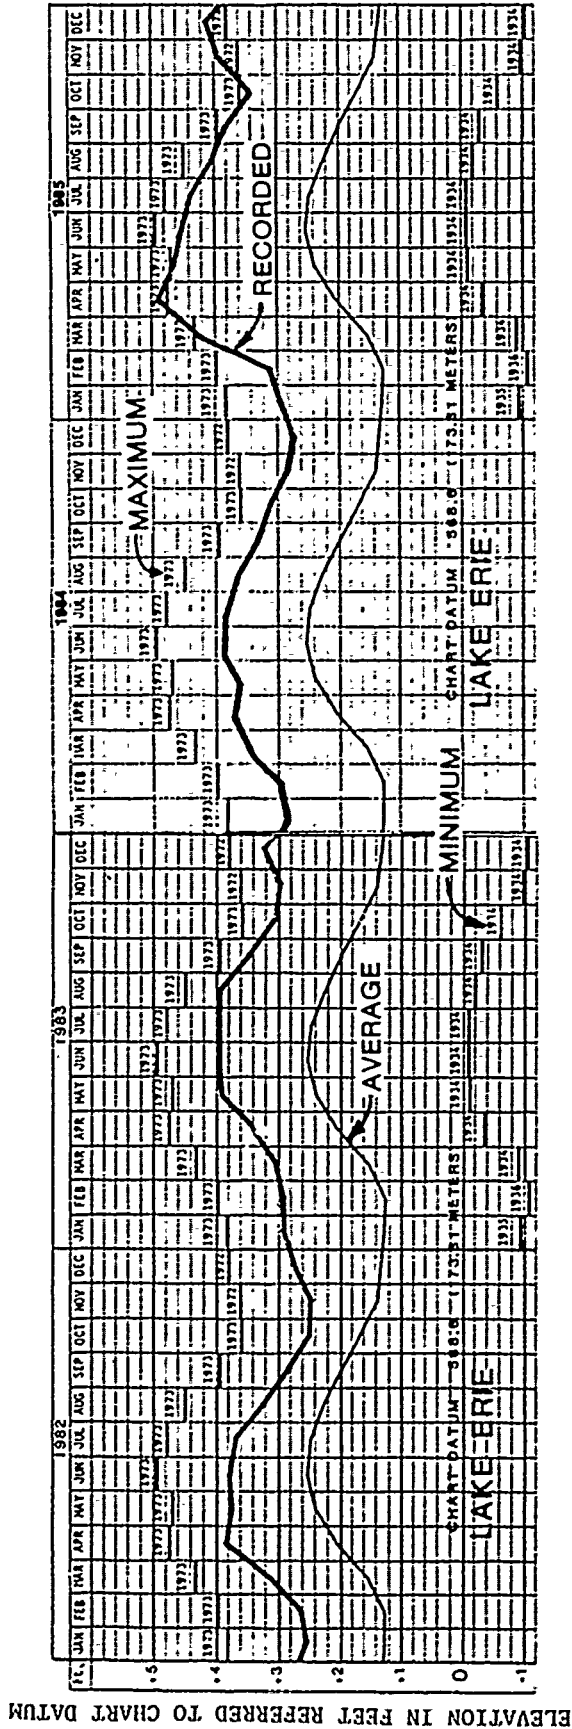
Figure 67. Monthly lake levels during monitoring program period

62. Figure 67 presents the monthly lake levels through the monitoring period (December 1982-June 1985). The Great Lakes experienced above-normal supplies (inflows) during this period resulting in levels 1.5 to 3 ft above average. Levels were increasing particularly near the end of the monitoring period and peaked the following year. The increase in water level partially explains the profile changes (i.e., erosion near and above water level with accretion farther offshore). In light of this change, it would be premature to compare the monitoring results with the predicted shoreline presented on Figure 14. Accretion immediately south of the breakwaters and erosion north of the breakwaters were predicted. The profiles south and north of the breakwaters have experienced a general net accretion, primarily occurring offshore.

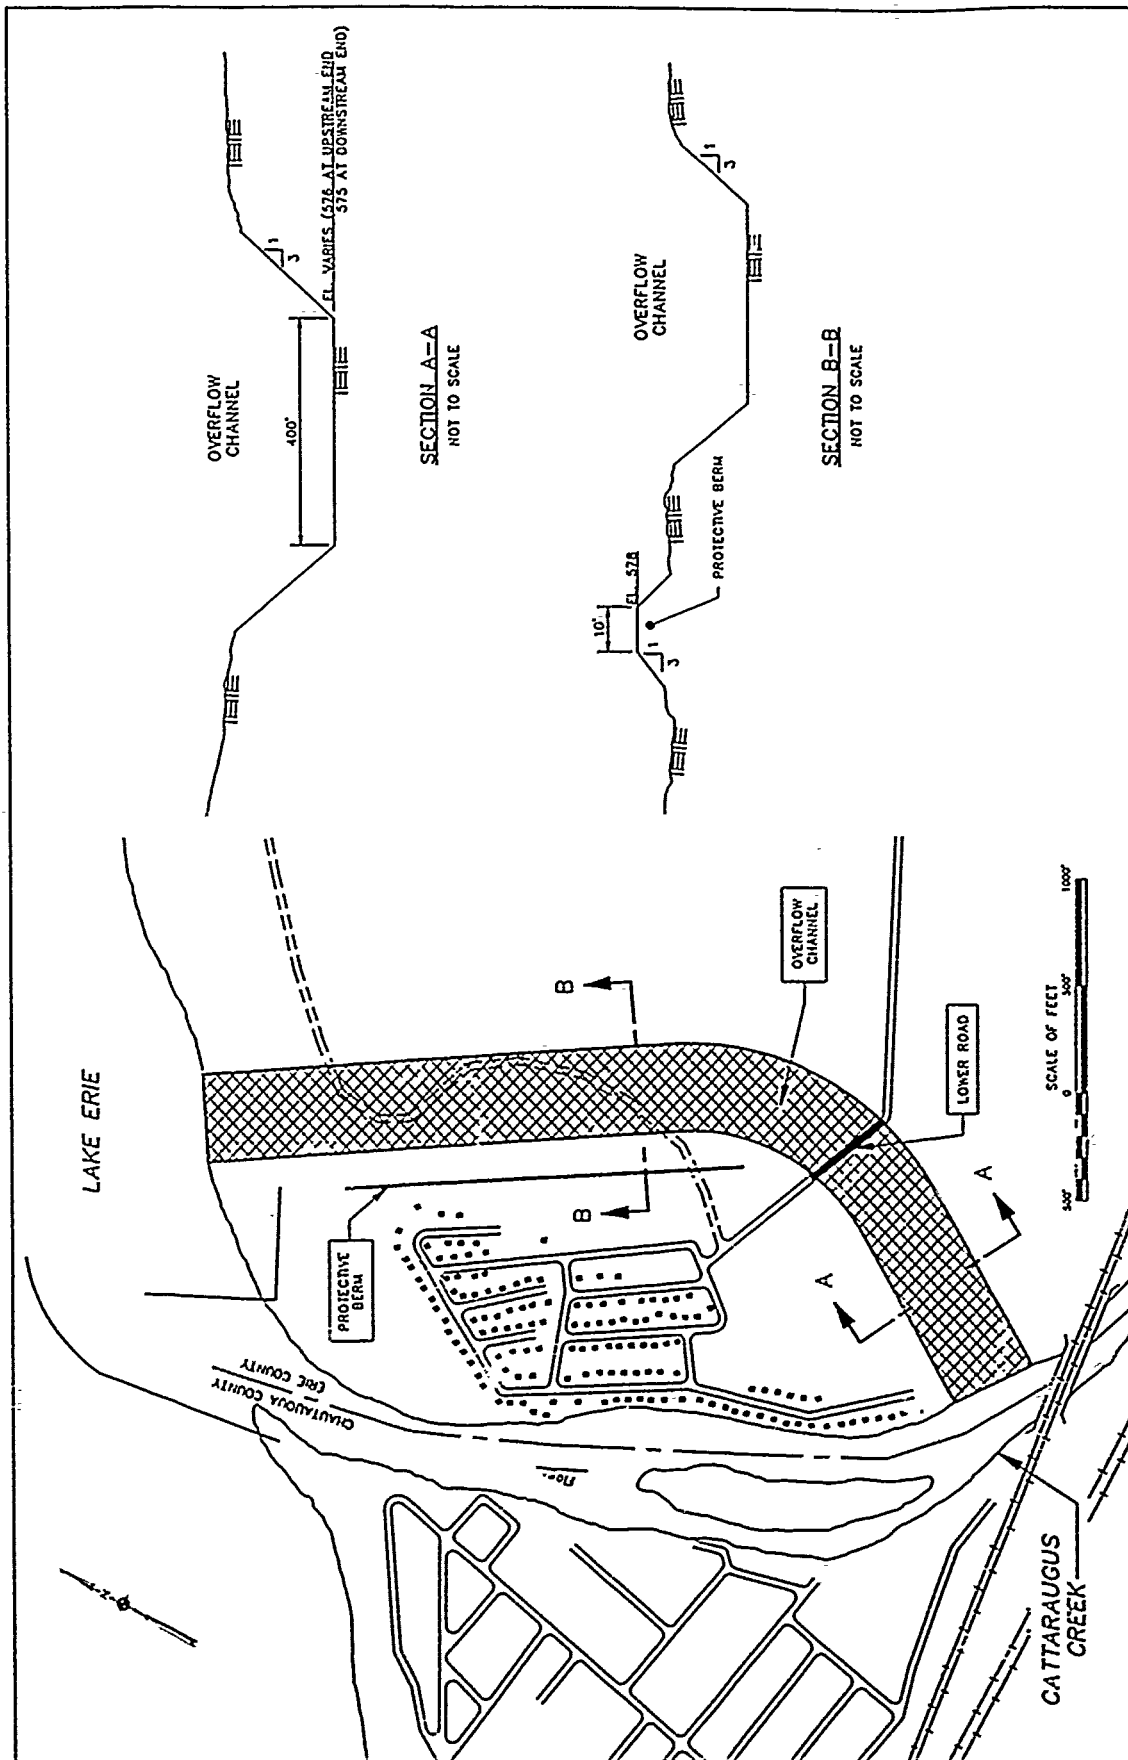
77. Two promising plans were the construction of an overflow channel in the right overbank near the mouth and the construction of an ice retention structure upstream of the town of Versailles. Further investigation of the overflow channel showed it to be not economically feasible. The plan would have consisted of a 4,600-ft-long overflow channel, 400 ft wide, and 2 to 3 ft in depth. A protective berm would be provided adjacent to the left bank of the channel to prevent the cottages in Snow's Marina from being flooded when the channel is carrying flood flows. The access road would be lowered where it crosses the channel, and the beach area at the downstream end of the overflow channel would also be lowered to +5.0 ft LWD. Maintenance dredging at the mouth of the channel and annual loosening and breaking the windrowed ice that forms along the lakeward margin of the beach berm would be performed. Beach profile data gathered under MCCC authority were used to evaluate the maintenance dredging requirement. This plan is presented in Figure 98.

Figure 98. Alternative Plan 3A
